# Manhole Inspection Summary

Manhole # S19Y\_\_026MH

Insp Date: **6/19/08 1:33 PM**

**Location** Address: **1914 somerworth st**

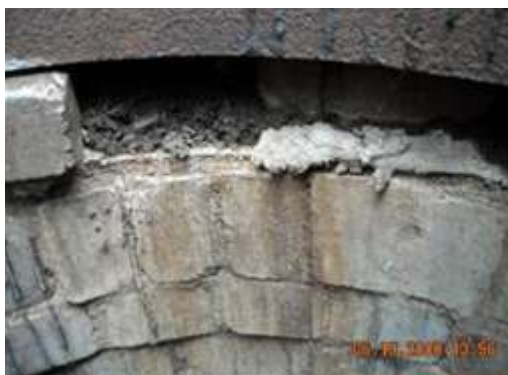
Defect 3

Condition: ☐ Sound ☒ **Cracked** ☐ Root Intrusion ☐ Loose Brick ☒ **Deteriorated**

deteriorated chimney

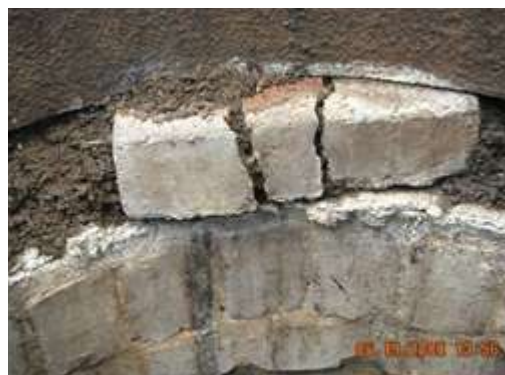
Defect 4

cracked chimney brick

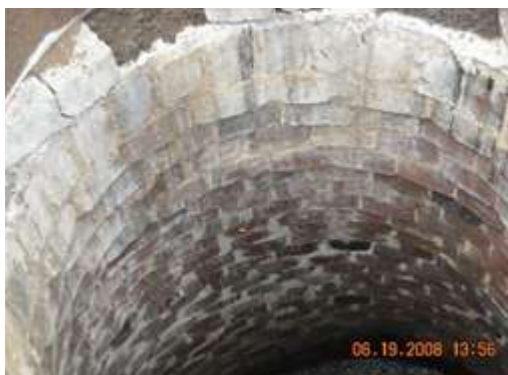
Defect 2

Infiltration: ☐ None ☒ **Joint** ☐ Cracks ☐ Mortar ☐ Roots ☐ Wall

infiltration @ corbel/chimney joint

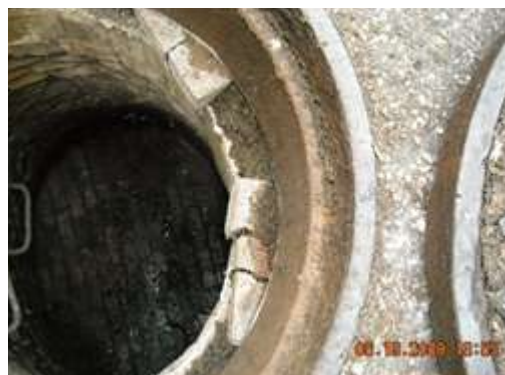
Defect 1

Offset: **2** (in.)

frame offset

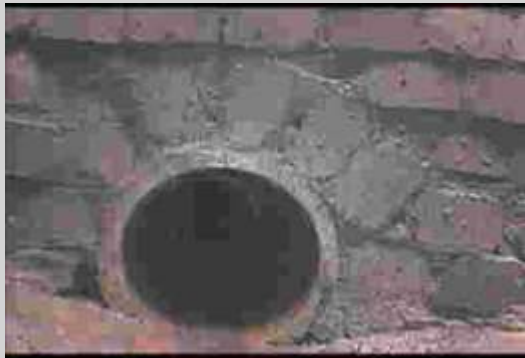
12 O'Clock Outflow

8 in. Circular Gravity Sewer  
Pipe Out @ 12 O'Clock

Pipe Height: **8.4** (in.) Rod and Bar (Angled)

Pipe Material: **Clay** ☐ Pipe Lined

Invert Depth: **7.08** (ft.) Flow Characteristics: **None**

Infiltration: **None** Pipe Seal Cond: **Sound**
